Folly Lane Trans Pennine Trail

Trans Pennine Trail – Folly Lane

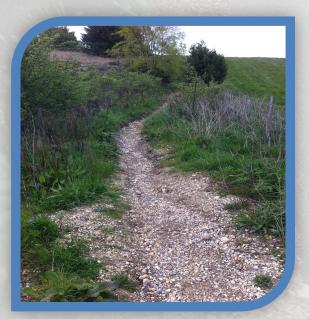
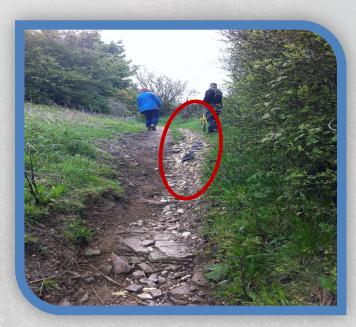
Below: The naturally formed path was also a nuisance for pedestrian users and cyclists, having gone past the point of being rugged terrain and into the realms of being unsafe. Below: The steep incline and rainwater run off had combined to erode the bridleway, making it unsafe for riders to take horse on to the Folly Lane stretch. Note the collapsed drainage pipe (circled) that was previously installed in an attempt to alleviate the erosion.

In order to ensure that the porosity of KBI Flexipave could be exploited, the sections of the path that ran over steep inclines involved baffles being dug into the ground prior to the material being laid. The baffles helped to slow down the natural desire of rainwater to run down the slope, promoting a more even distribution of rainwater directly into the ground beneath the surface. The baffles also act as a break to minimise the migration of the stone sub-base beneath the path, ensuring a more stable overall surface.

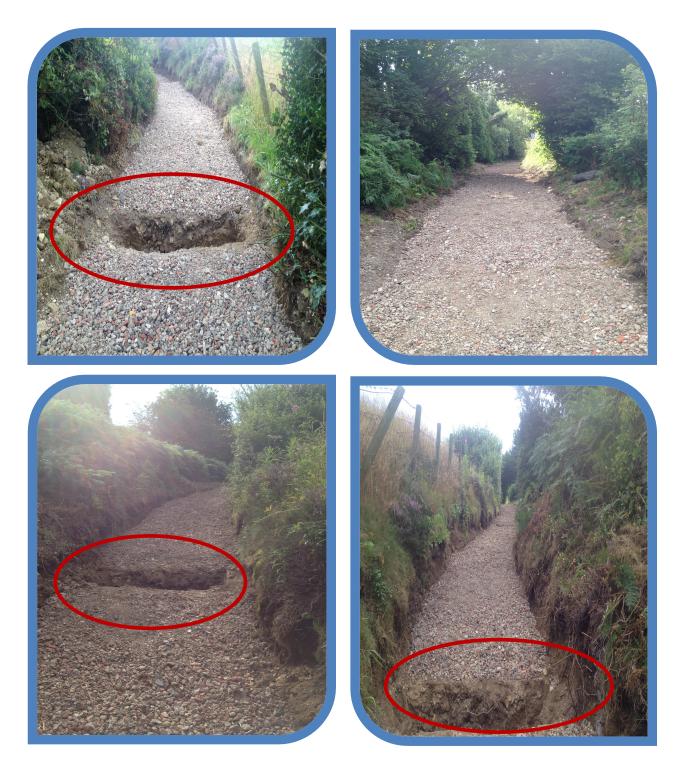
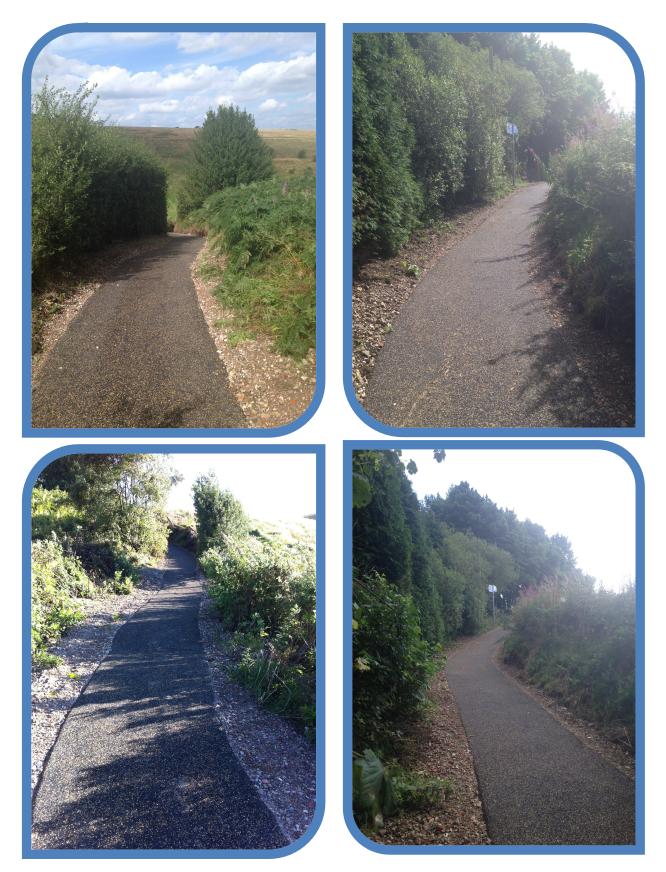
Having widened the existing path, baffles were dug into the steeper inclines to allow water to effectively recharge back into the ground after penetrating through the KBI Flexipave. The baffles (circled) also reduce the migration of the stone used within the sub-base, helping to ensure a stable path.

Once dug, each baffle was filled with KBI Flexipave, eliminating the possibility of the channel becoming clogged whilst still allowing the free movement of water.

The use of baffles – which were dug at various intervals along the slopes – helps to attenuate the flow of water down the slope once it passes through the KBI Flexipave. The baffles also establish a stronger path as they stem the migration of the stone sub-base - a simple yet effective solution to ensuring that the pathway behaves exactly as it should.

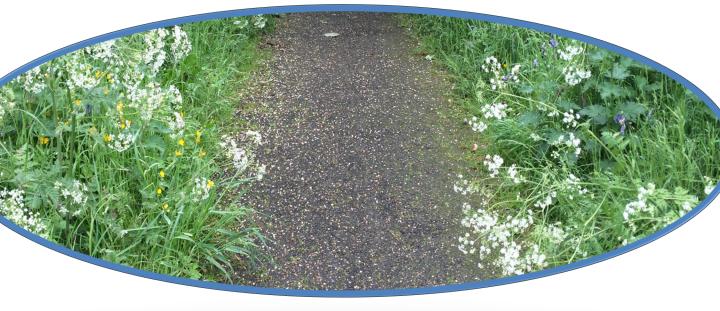
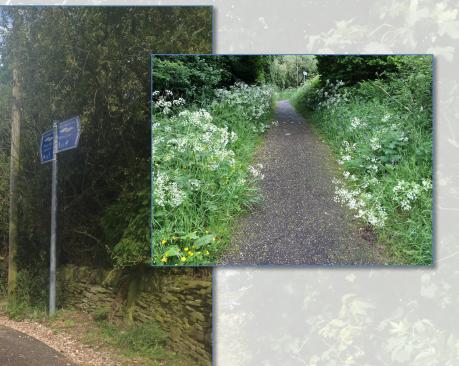
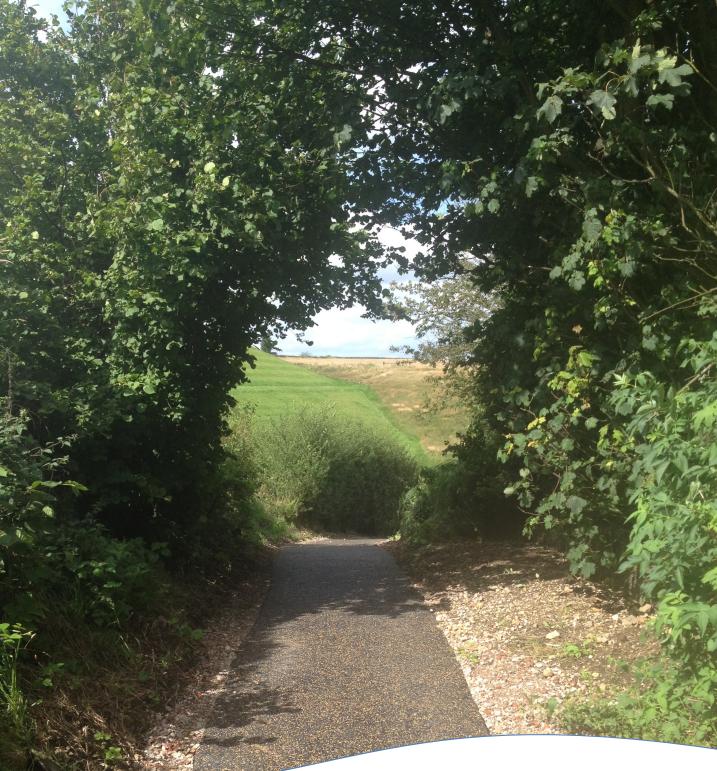
The finished bridleway conforms to the natural contours of the original path and is completely porous. The recycled rubber used within the material not only makes it eco-friendly, it reduces the impact on the leg joints of the horses using the bridleway.

This page: Despite challenging conditions and difficult terrain, the Folly Lane stretch of the Trans Pennine Trail is now fully accessible to equestrian users as well as pedestrians and cyclists. With erosion no longer a problem, the path also benefits from zero standing water.
